Manhole Inspection Summary

Manhole # S03GG2005MH

Insp Date: **7/11/06 12:00 AM**

Location Address: **2929 FALLSTAFF RD**

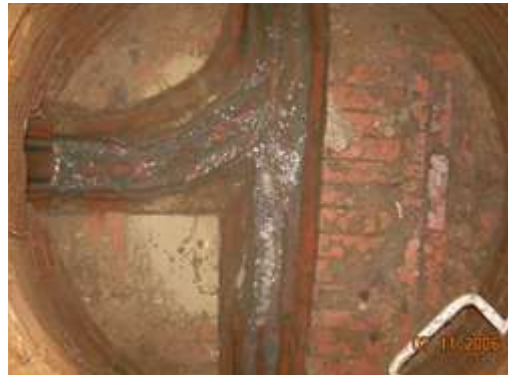
Top View

Bench debris.

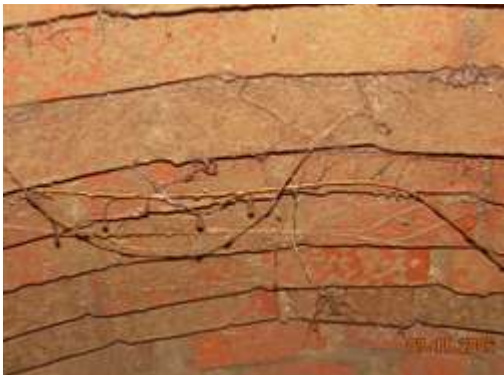
Defect

Condition: ☐ Sound ☐ Cracked ☒ **Root Intrusion** ☐ Loose Brick ☐ Deteriorated

Infiltration: ☐ None ☒ **Joint** ☐ Cracks ☐ Mortar ☒ **Roots** ☐ Wall

Infiltration: ☐ None ☐ Joint ☐ Cracks ☒ **Mortar** ☒ **Roots** ☒ **Wall**

Adjustment and Corbel root intrusion.
Adjustment and Corbel infiltration.

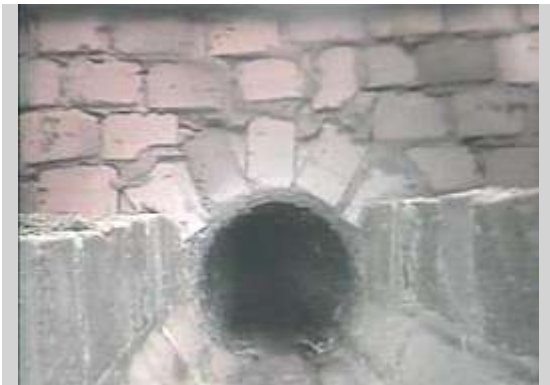
8 in. Circular Gravity Sewer Pipe In @ 6 O'Clock

Infiltration: **Evidence** Pipe Seal Cond: **Unknown**
